ANALYSIS OF ROAD DAMAGE USING THE SURFACE DISTRESS INDEX (SDI) METHOD ON THE GRESIK-SURABAYA ROAD SECTION KM. 4+900 TO KM. 7+700**Sebastianus Priambodo, Judiono, Ikhwanuddin****University of Sunan Giri Surabaya**

Abstract- This Gresik-Surabaya road section is located north of Surabaya City. The road is under the authority of the East Java-Bali National Road Implementation Center. The Gresik-Surabaya road section is one of the connecting accesses between Surabaya City and Gresik Regency, which has damage to the road body. Overloaded heavy vehicles often pass through the road, which can cause damage to the road surface and cause problems such as decreased speed and travel time, as well as threaten the safety of road users or cause accidents. The purpose of the research on the Gresik-Surabaya road section, km. 4 + 900 to km. 7 + 700, is to find the value of the Surface Distress Index (SDI) on a 2.8 km long study. The SDI method is carried out by sampling data with visual surveys using a road damage survey form (SKJ) or what is commonly called a Road Condition Survey (RCS), which is divided every 100 meters. So that the results obtained on the Gresik Surabaya road section, East Java,

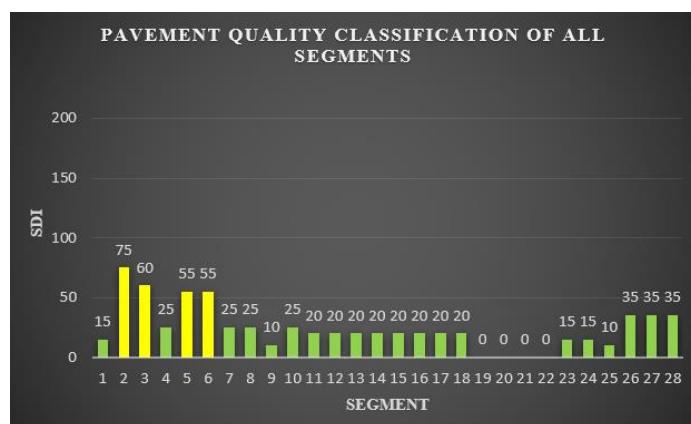
Figure 4. SDI Value Graph of the entire Segment

Based on the graph of the SDI value of the entire segment, it can be seen that the level of damage that gets a medium SDI value is in segment 2, where the segment gets an SDI value of 75, while the lowest value is in segments 19 to 22, which gets an SDI value of 0, where in the segment there is no damage and the pavement in the segment is in good condition. The average SDI value on the Gresik-Surabaya road section, Km 4 + 900 to Km 7 + 700, is a road in good condition that only requires repair and maintenance on several segments.

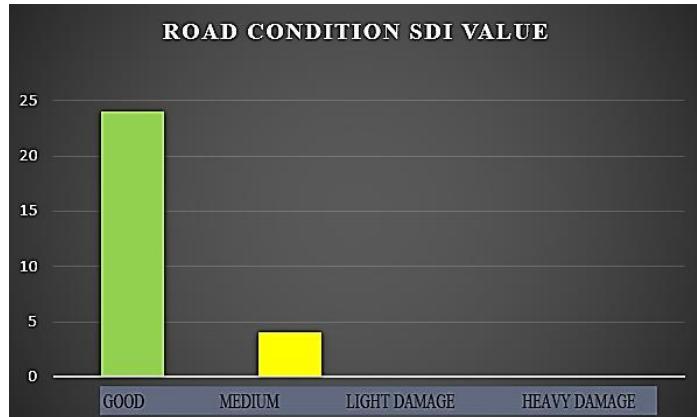
Figure 5. Graph of Road Condition Value

Based on Figure 6, The Road Condition Value Graph shows that of the 28 segments on the Gresik-Surabaya road section, 24 segments get a good value and 4 segments get a moderate road condition value, namely in segments 2, 3, 5, and 6, where at that location there is quite a lot of crack damage.

The road damage handling method used on road damage on Gresik Road in Surabaya City refers to Bina Marga 2011. An example of handling that can be taken is damage to segment 2 because the road conditions get a medium SDI value. The following is the road handling method for segment 2.
