ANALYSIS OF ROAD DAMAGE USING THE SURFACE DISTRESS INDEX (SDI) METHOD ON THE GRESIK-SURABAYA ROAD SECTION KM. 4+900 TO KM. 7+700

Sebastianus Priambodo, Judiono, Ikhwanuddin

Universitas Sunan Giri Surabaya

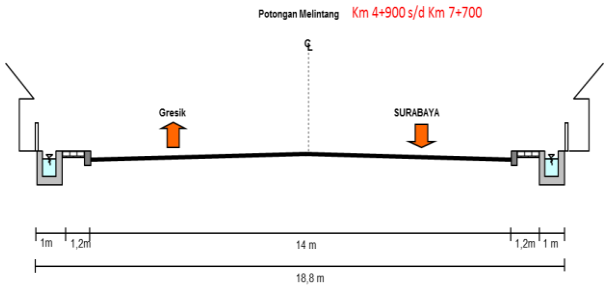
Figure 1 Cross section of Jl. Gresik Km 4+900 to Km 7+700
(source: PPK 3.4 Prov Jatim data)

Measurement of road surface damage carried out on Jl. Gresik (Surabaya) along 2800 meters on February 27, 2022 The data collection method is direct observation or visual condition survey, followed by data calculation using calculations based on the parameters of the Surface Distress Index (SDI) method. With a total measurement length of 2800 meters and an area of each segment of 1400 m2 (100 m x 14 m). Assessment of road surface damage uses primary data obtained from direct observation in the field with parameters such as the area of cracks in each segment, crack width, number of holes, and vehicle ruts. Cross section of Gresik Surabaya road segments 1 to 28 from Km 4+900 to Km 7+700 With a total width of the Road Property Area (DMJ) of 18.8 meters, a road width of 14 meters, a sidewalk width of 1.2 meters, and a channel width of 1 meter.

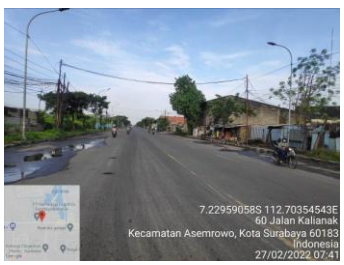
Figure 2.
Condition of Jl. Gresik Km 4+900

Figures 2 and 3 are the conditions of the Gresik Km 4+900 road section located on Jalan Kalianak, Kalianak village, Asemrowo sub-district. The photo of the condition was taken on February 27, 2022, precisely at the beginning of a road condition survey on the road section. It can be seen from the photo that a lot of water is stagnant on the road body, indicating that the road is uneven. Therefore, a road condition survey can be carried out using the Surface Distress Index (SDI) method. Damage also occurs in the final segment of the study, namely Km 7 + 700.

It can be seen in the photo image of the KM 7 + 700 Gresik road condition that damage occurs on asphalt pavement, namely holes, puddles, and ruts. With these conditions, a road condition survey can be carried out using the Surface Distress Index (SDI) method.

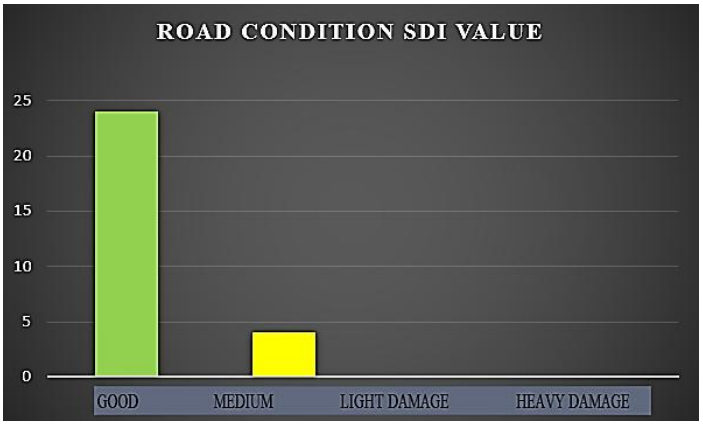
Figure 5. Graph of Road Condition Value

Based on Figure 6, The Road Condition Value Graph shows that of the 28 segments on the Gresik-Surabaya road section, 24 segments get a good value and 4 segments get a moderate road condition value, namely in segments 2, 3, 5, and 6, where at that location there is quite a lot of crack damage.
